Manhole Inspection Summary

Manhole # S05UU1013MH

Insp Date: **9/26/06 11:02 AM**

Location Address: **5703 HIGHGATE DR**

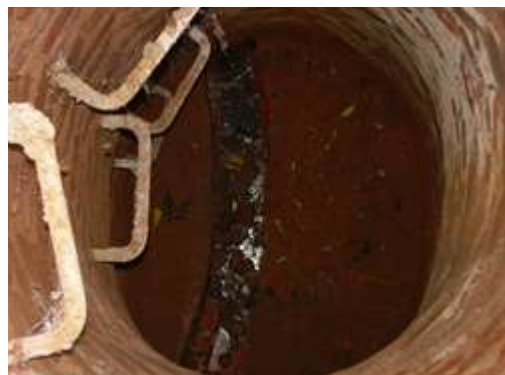
Top View

Adjustment and Barrel infiltration.
Evidence of surcharge - Bench debris.
Channel debris. Corroded steps.

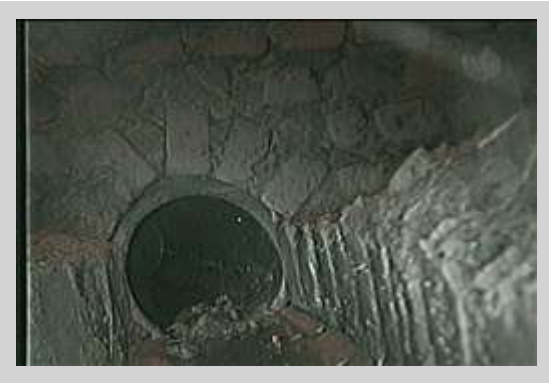
8 in. Circular Gravity Sewer Pipe Out @ 12 O'Clock

Barrel deterioration and infiltration. Channel deterioration.

Infiltration: **Evidence** Pipe Seal Cond: **Unknown**

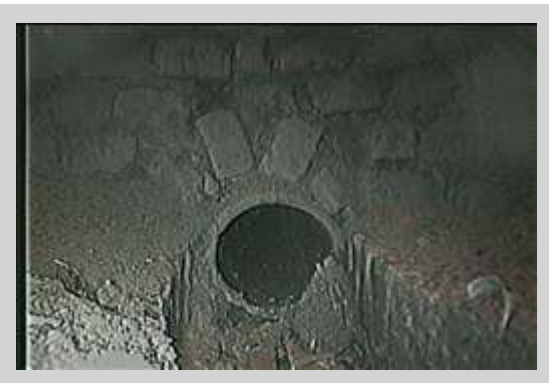
6 in. Circular Gravity Sewer Pipe In @ 7 O'Clock

Barrel deterioration and infiltration. Channel deterioration and debris.

Infiltration: **Evidence** Pipe Seal Cond: **Unknown**
